Dealer Service Instructions for:

Safety Recall U48 / NHTSA 18V-343

Steering Intermediate Shaft

2018 (JL) Jeep® Wrangler

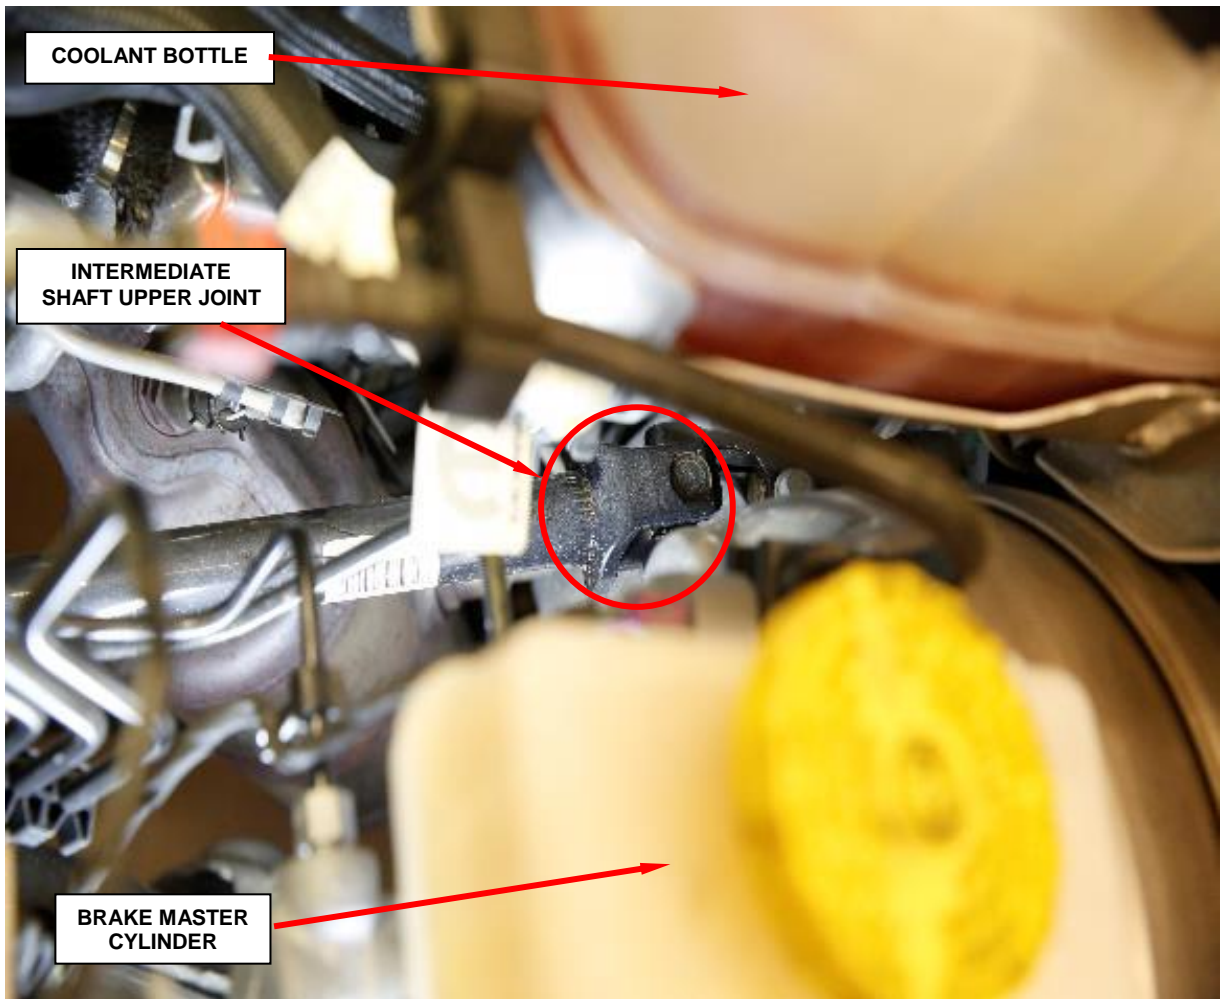
Figure 1 – Intermediate Shaft Location (3.6L shown)

1. Locate the intermediate shaft upper joint, intermediate shaft to steering column (Figure 1).

NOTE: The intermediate shaft upper joint is located in the under hood compartment right below the coolant bottle (Figure 1).

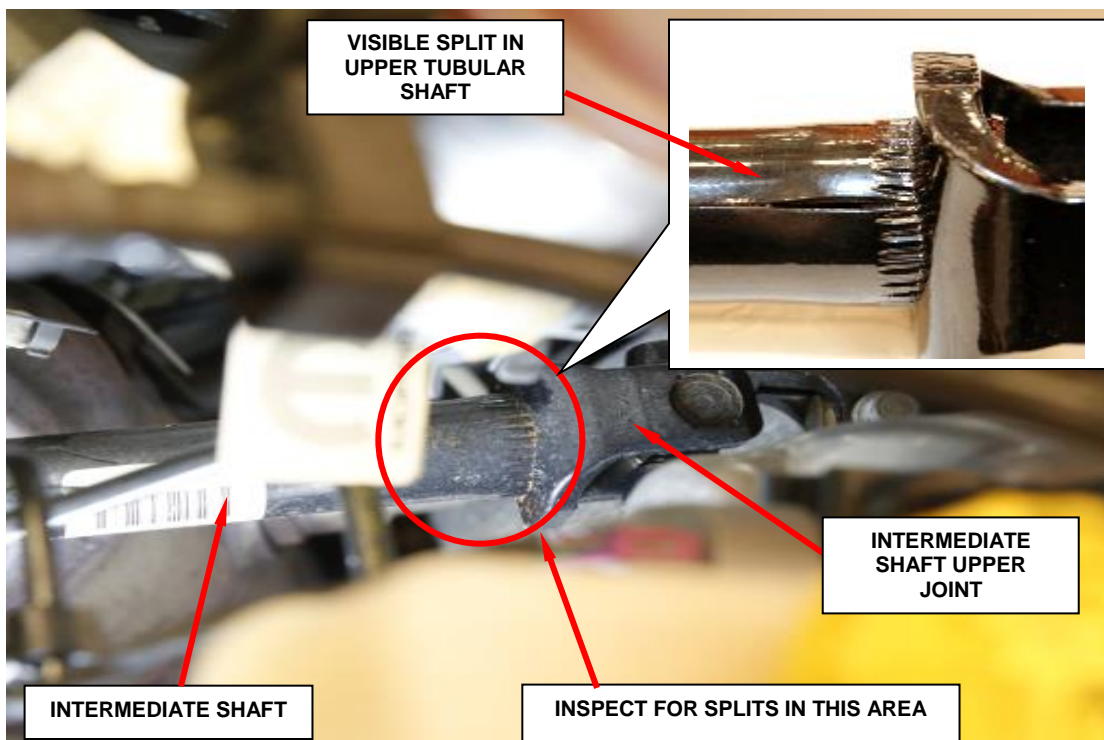
Figure 2 – Inspect for Splits

The steering intermediate shaft on about 530 of the above vehicles may have an incomplete long seam weld, which may result in a split where the external spline is formed. Under high steering wheel torque, the intermediate shaft may index on the spline, causing the steering wheel to lose center positioning. Emergency maneuvers may result in diminished steering responsiveness, which can cause a vehicle crash without prior warning.

2. Inspect upper tubular shaft/stake yoke connection for splits (2-person inspection).
 - a. Start the engine to assist in turning the steering wheel.
 - b. Person # 1: With a flash light visually look for splits on the upper tubular shaft/stake yoke connection (Figure 2).
 - c. Person # 2: Slowly rotate steering wheel in coordination with Person # 1 to make sure the entire tube diameter (360 deg.) has been inspected for visible splits.
 - d. Turn the engine off.
 - If any splits were observed, continue to Section **B. Replace Intermediate Shaft.**
 - If **no** splits were observed, close the hood and return the vehicle to the customer.

Inspect the steering intermediate shaft of the suspect population of vehicles and replace the shaft if necessary
